ALL HOUSE INSPECTIONS

STANDARD PROPERTY & TIMBER PEST REPORT

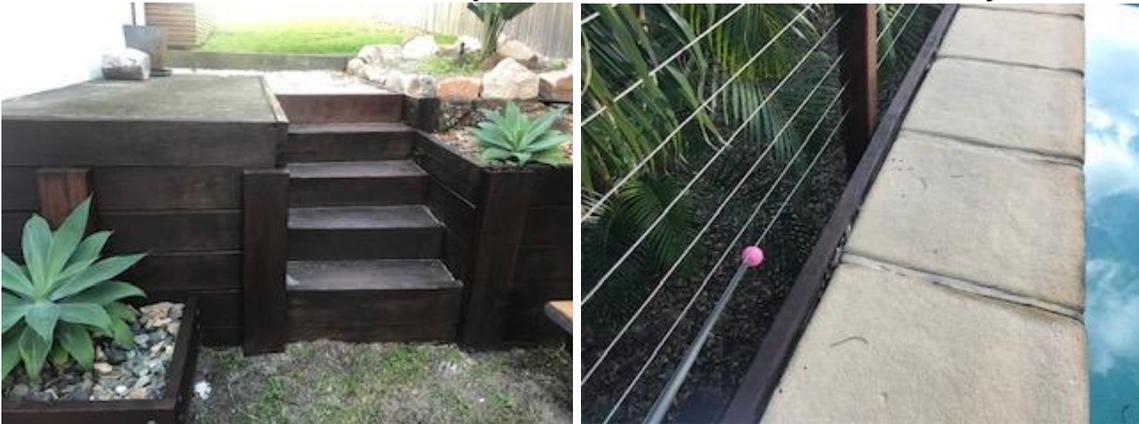
Balustrades/ handrails displayed: Gaps exceeding 125mm maximum i.e. pool deck/ stairs / Missing where someone can fall over 1.0m i.e. eastern retaining wall. As a duty of care I recommend Balustrades/ handrails be brought in compliance with current requirements of 1.0m minimum height (865 for stairs) and have a maximum gap of 125mm. As a duty of care I recommend Balustrades/handrails are installed where someone can fall over 1.0m to finished surface level i.e. decks, stairs, tops of retaining walls etc – This is an extreme safety risk to occupants/ visitors of/ to the property & is a major defect. I recommend a licensed Contractor further inspect for rectification – immediately.

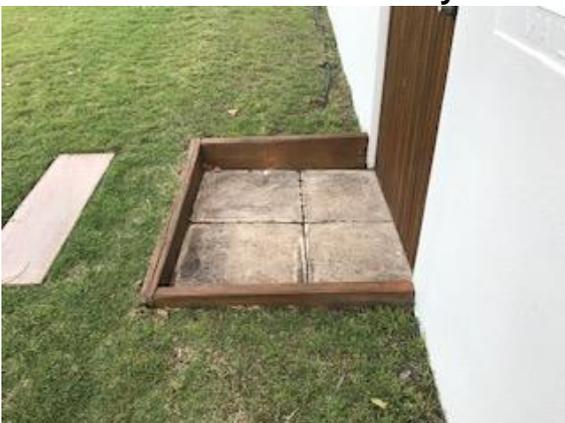
Sleepers constructed on the footpath. This is a safety risk to the public/ occupants/ visitors of/ to the property & is a major defect. I recommend a licensed Contractor further inspect for rectification – immediately.

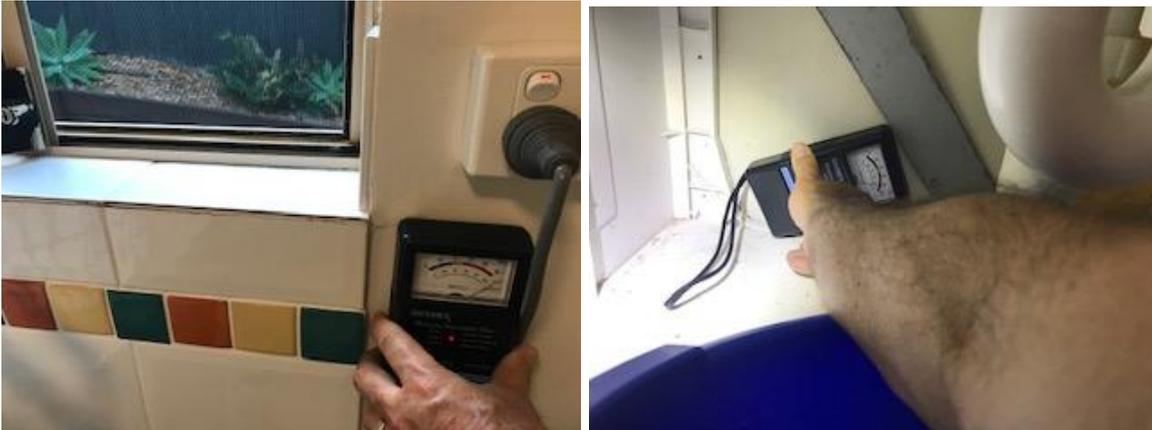
High moisture readings were evident to but not limited to: Lower storey walls i.e. external walls as shown. Typical causes being poorly installed and/or Missing DPC (Damp Proof Course) and/or Flashing and/or Water proofing. These parts of the building will be prone to damp issues in its lifetime which offers conditions conducive to: Moisture entry/ termites/ decay/ mould growth and/or Structural damage to primary elements i.e. timber framing and/or Secondary elements i.e. interior linings/ coverings. High moisture readings can also be caused by termites. As a safeguard to you an invasive inspection is recommended to further investigate the cause and the extent of any damage. Any moisture/ decay/ timber pest affected timbers/ members then be treated with an anti-fungicide treatment and/or sealed/ oiled/ weather proofed and/or rectified as required. I recommend a licensed Water proofing consultant and/or Contractor further inspect for rectification – immediately.

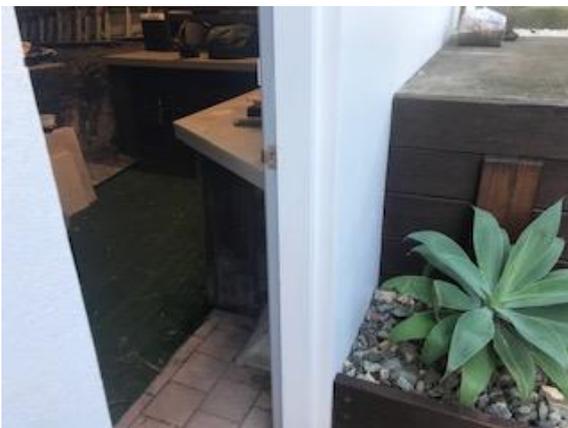
It was noted floor levels were at a similar height to and/or below external ground levels to: Lower storey i.e. north. These parts of the building will be prone to damp issues in its lifetime which offers conditions conducive to: Moisture entry/ termites/ decay/ mould growth and/or Structural damage to primary elements i.e. timber framing and/or Secondary elements i.e. interior linings/ coverings. I recommend a licensed Water proofing consultant and/or Contractor further inspect for rectification – immediately.

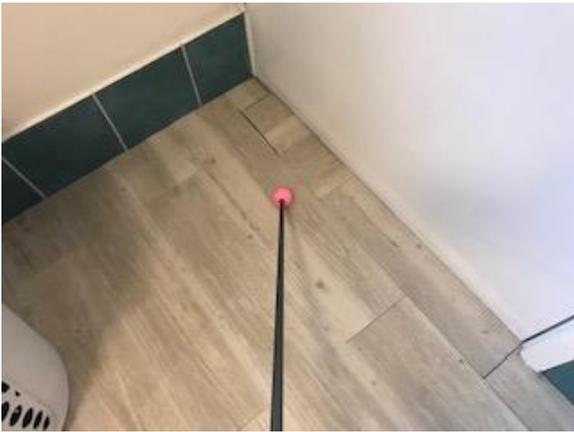
Moisture staining and/or damage was evident to: Lino i.e. south of laundry area. Typical cause being Poorly installed and/or Missing DPC (Damp Proof Course) and/or flashing and/or vapour barrier and/or water proofing. These parts of the building will be prone to damp issues in its lifetime which offers conditions conducive to: Moisture entry/ termites/ decay/ mould growth and/or Structural damage to primary elements i.e. timber framing and/or Secondary elements i.e. interior linings/ coverings. As a safeguard to you an invasive inspection is strongly recommended (wall area) to further investigate the cause and extent of any damage and any moisture/ decay/ timber pest affected timbers be treated with an anti-fungicide and/or rectified. This may become a structural type defect. I recommend a licensed Water proofing consultant and/or Contractor further inspect for rectification – immediately.

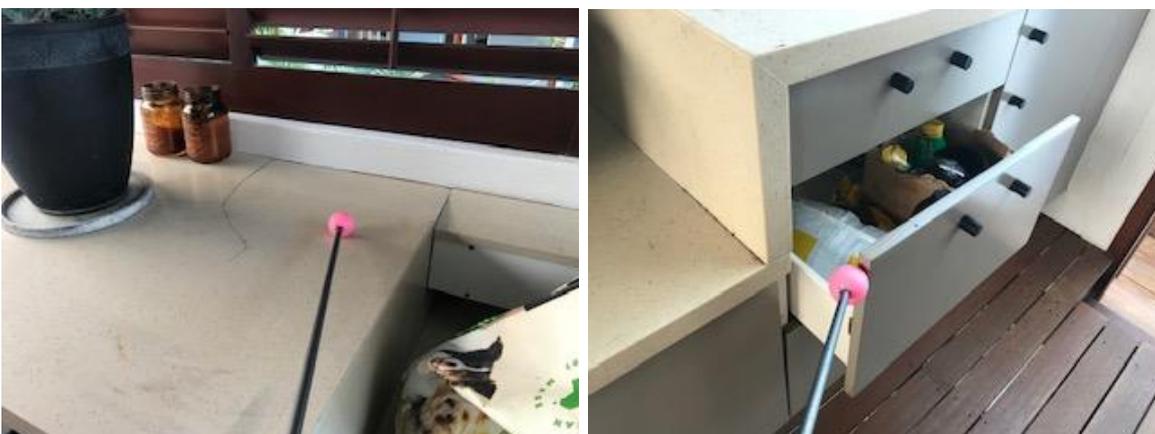
BBQ bench/ cabinets were in failing/ poor condition. I recommend a licensed Contractor further inspect for rectification – immediately.

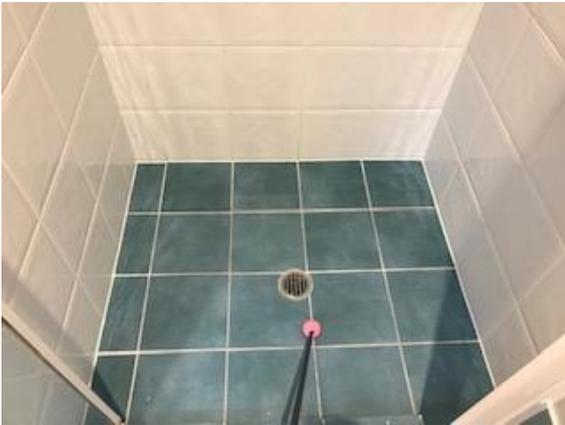
Drummy (poor installation and/or adhesive failure) floor tiles to: Lower shower recess. These tiles will be prone to lifting/ cracking and grout cracking (This may also compromise the water proofing membrane). I recommend a licensed Tiler and/or Contractor further inspect for rectification – immediately.

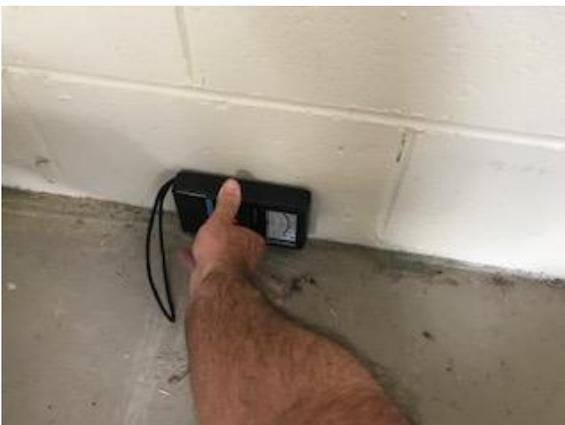
Moisture readings were evident adjacent (externally) to: Lower shower recess i.e. blockwork to garage. Its possible this may be a rising damp issue and not a plumbing type issue. I recommend a licensed Plumber and/or Contractor further investigate for cause and rectify as required i.e. leaking tap valves/ pipe work, poor sealant to tap cover plates/ shower screen and/or a failed water proofing membrane etc. High moisture readings can also be caused by termites. As a safeguard to you an invasive inspection is recommended to further investigate the cause and the extent of any damage. Any moisture/ decay/ timber pest affected timbers/ members then be treated with an anti-fungicide treatment and/or sealed/ oiled/ weather proofed and/or rectified as required. I recommend a licensed Plumber and/or Water proofing consultant and/or Contractor further inspect for rectification – immediately. This may also become a structural type defect.

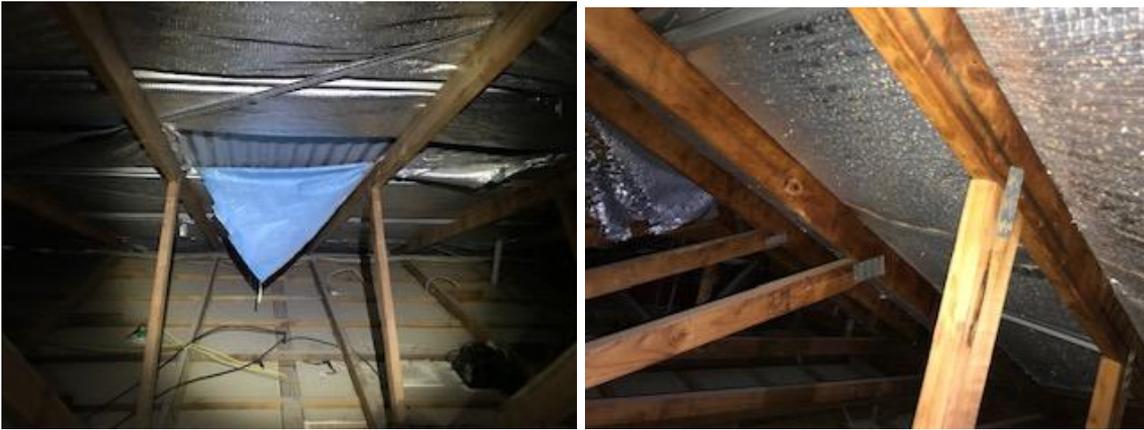
Sarking/ sisilation in deteriorating/ failing condition. I recommend a licensed Contractor further inspect the above defects for rectification – immediately.

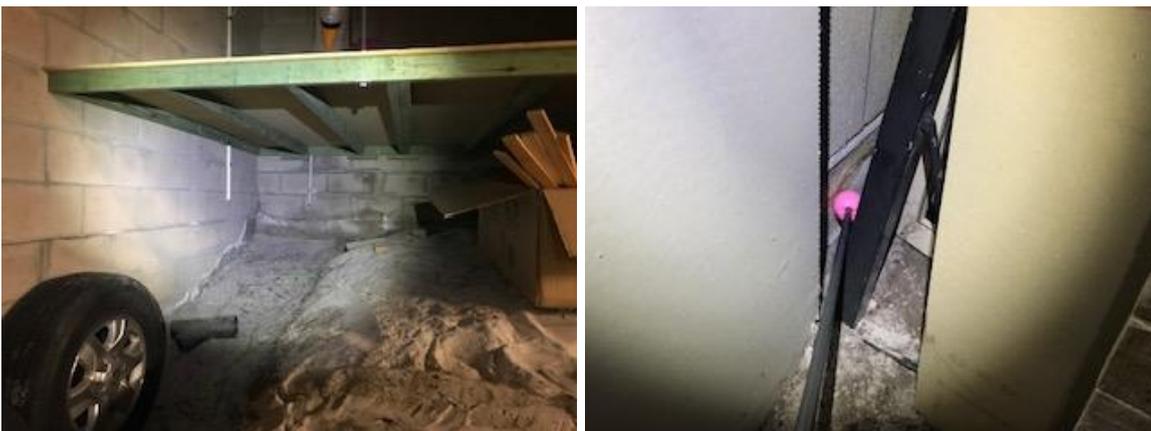
Poor ventilation that offers conditions conducive to moisture entry/ termites/ decay/ mould growth and/or Structural damage to primary elements i.e. timber framing and/or damage to Secondary elements i.e. interior linings/ coverings. I recommend a licensed Contractor further inspect for rectification – immediately.

Subfloor area displayed dampness/ efflorescence to: Blockwork walls. This offers conditions conducive to moisture entry/ termites/ decay/ mould growth and/or Structural damage to primary elements i.e. timber framing and/or damage to Secondary elements i.e. interior linings/ coverings. The current NCC requirement is for surrounds to slope away from external walls at a slope of 50mm for a distance of 1.0m minimum and/or spoon drains be instated up hill to divert water around the building/s. I recommend a licensed Contractor further inspect for rectification – immediately.

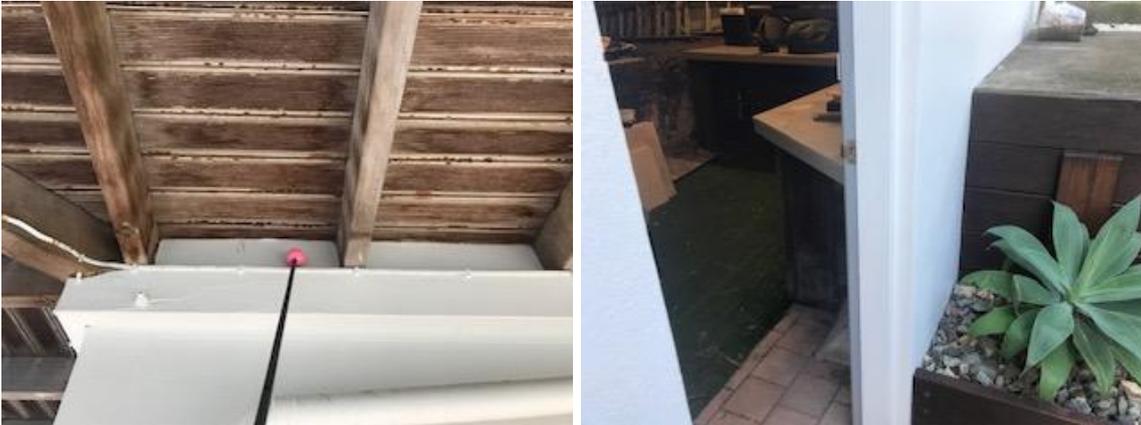
Direct ground contact and/or Poorly installed and/or missing and/or no DPC (Damp Proof Course) and/or flashing visible i.e. blockwork areas including deck junctions. I recommend a licensed Contractor further inspect for rectification – immediately.

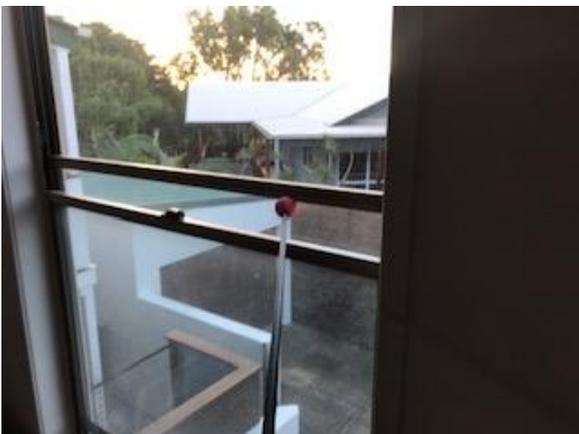
The window sash springs were in failing/ failed condition to double hung windows i.e. not holding sash up/ taking weight of sash to NW bedroom. I recommend a licensed Contractor further inspect for rectification – immediately.

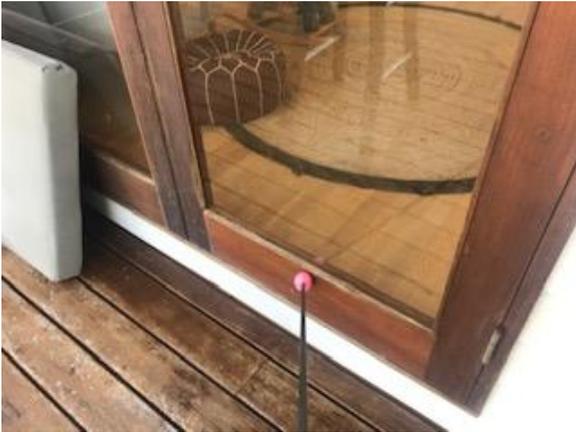
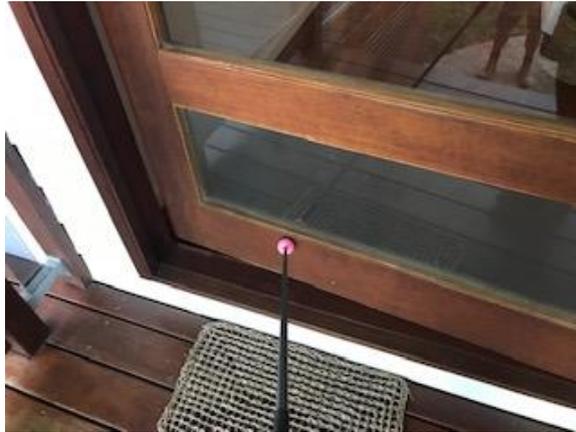
Poor paint/ oil cover that offers conditions conducive to moisture entry/ termites/ decay/ mould growth and/or Structural damage i.e. northern entry/ French doors. I recommend a licensed Contractor further inspect for rectification – immediately.

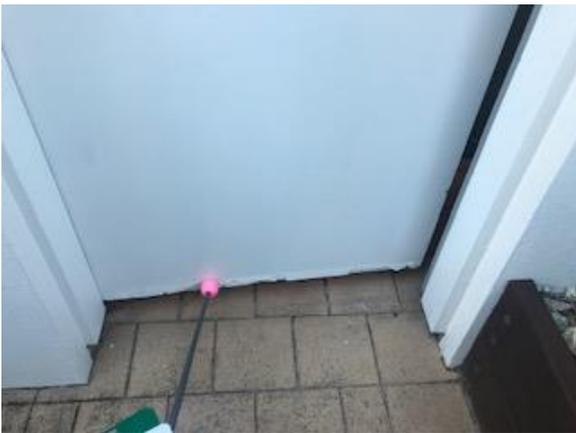
Early to moderate / advanced stages of weathering / moisture damage to: Subfloor eastern door. Any moisture/ decay/ timber pest affected timbers/ members be treated with an anti-fungicide treatment and/or sealed/ oiled/ weather proofed and/or rectified as required. I recommend a licensed Contractor further inspect for rectification and/or a licensed Structural engineer certify as sound – immediately.

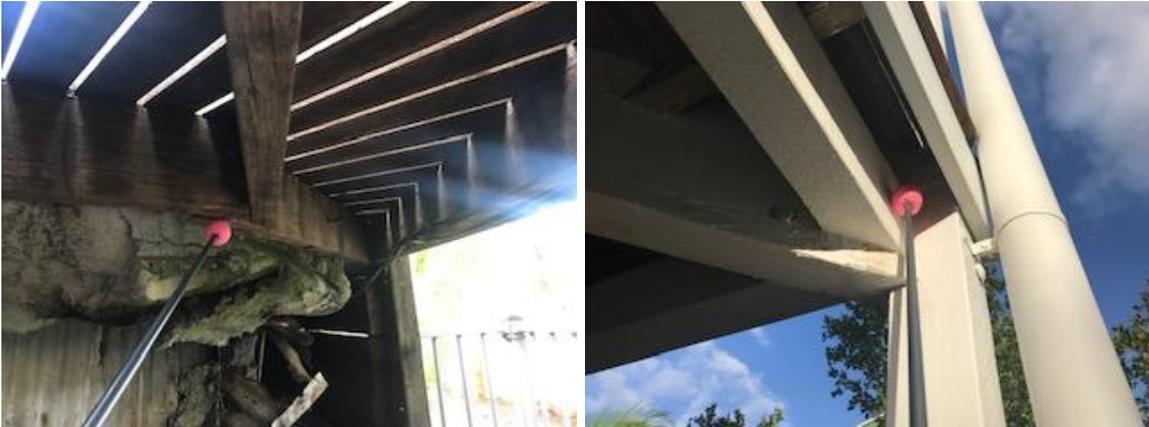
I recommend a licensed Contractor further inspect for rectification and/or a licensed Structural Engineer certify as sound: Floor joist construction/ support in part to pool deck; Bearer construction/ support to roofed deck i.e. SE. This is a possible safety risk to occupants/ visitors of/ to the property and a structural type issue - immediately.

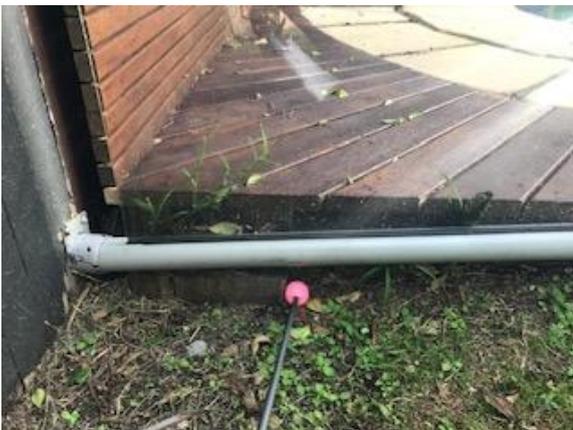
Timbers in contact with ground to: Pool deck in part etc to property are not recommended as they offer conditions conducive to mould growth, decay, termites and/or Structural damage and should preferably be rectified/ removed. I recommend a licensed Contractor further inspect for rectification – immediately.

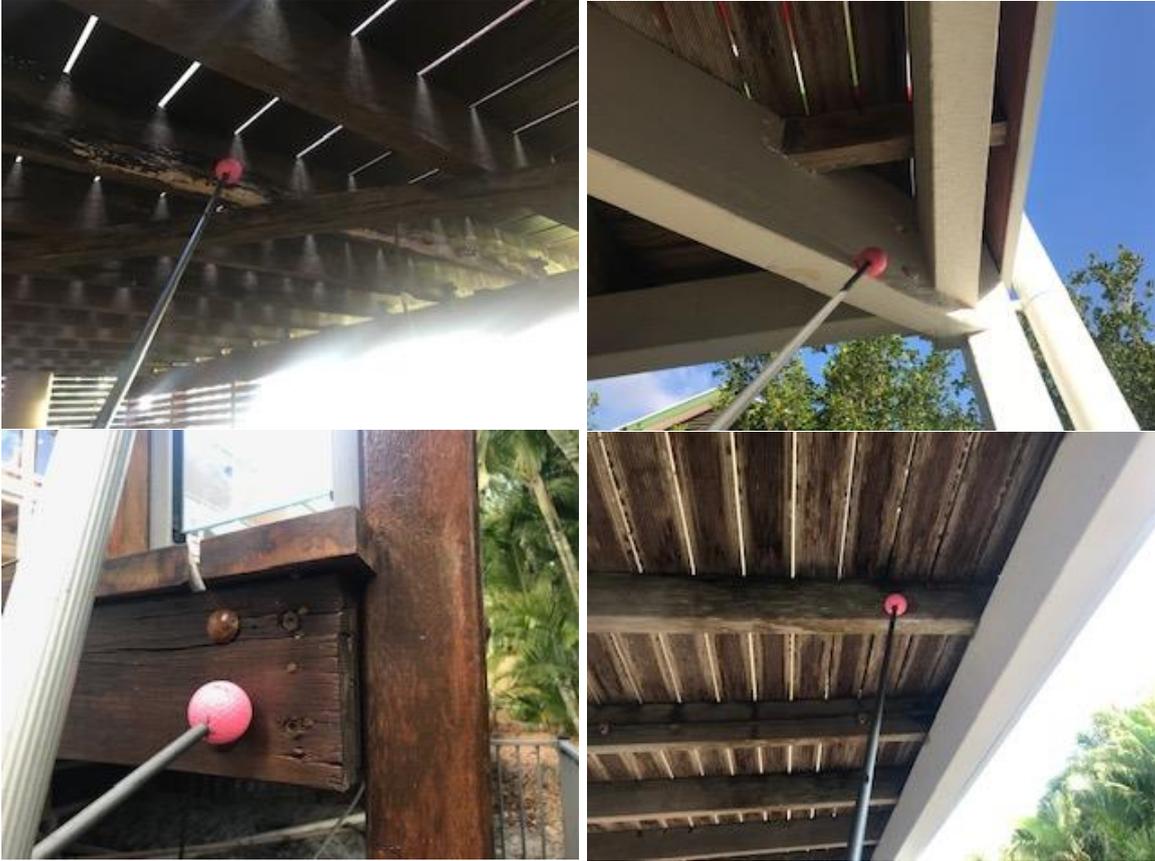
Poor paint/ oil cover to: Pergola deck i.e. NE; Roofed decks i.e. east/south/ west; Pool deck i.e. south etc that offers conditions conducive to moisture entry/ termites/ decay/ mould growth and/or Structural damage. I recommend a licensed Contractor further inspect for rectification – immediately.

Early to moderate / advanced stages of weathering/ splitting and/or decay/ moisture damage to: Pergola deck i.e. NE; Roofed decks i.e. east/south/ west; Pool deck i.e. south. This is also a structural type defect. An invasive inspection is recommended to further investigate the cause and the extent of any damage. Any moisture/ decay/ timber pest affected timbers/ members then be treated with an anti-fungicide treatment and/or sealed/ oiled/ weather proofed and/or rectified as required. I recommend a licensed Contractor further inspect for rectification and/or a licensed Structural engineer certify as sound – immediately.

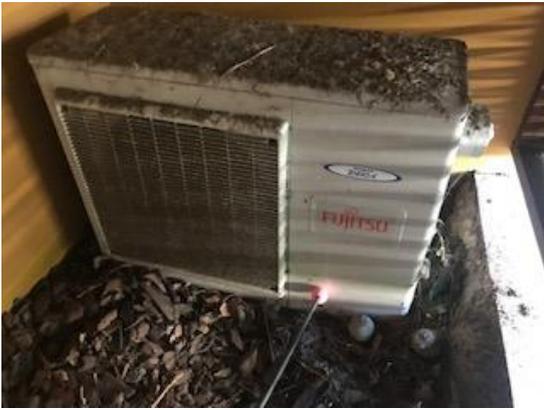
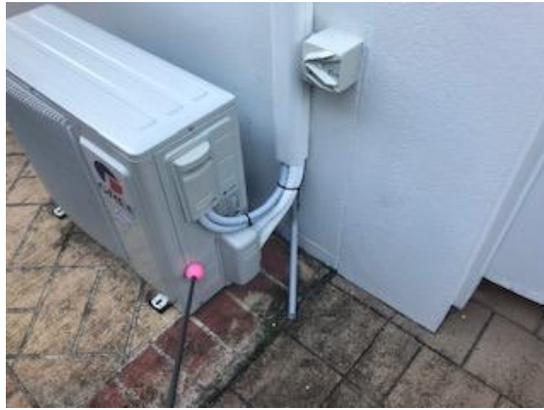
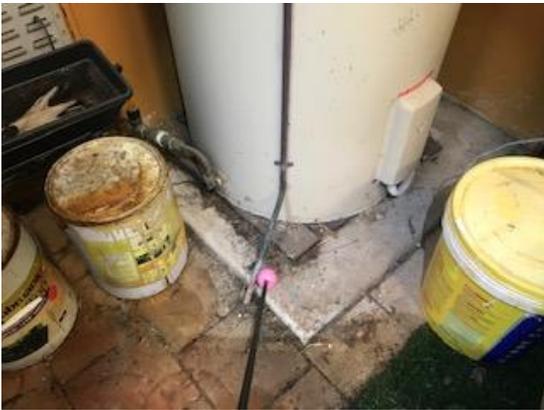
Air conditioner (direct ground contact also evident i.e. north) & Hotwater system drains discharging to ground. Poor drainage offers conditions conducive to termites/ mould/ decay and/or footing movement. I recommend a licensed Contractor further inspect for rectification – immediately.

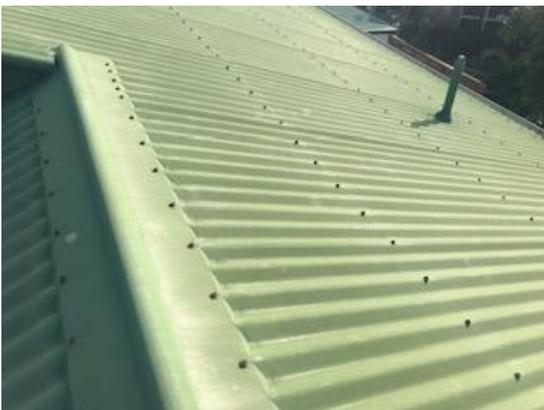
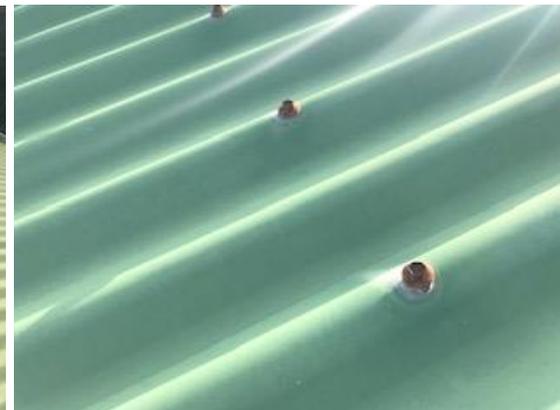
Wearing/ fading/ wearing of the painted roof coating / Early stages of corrosion that should be spot treated/ coated to the surface coating i.e. near roof screws. The roof was due for a roof restoration type coating/ repainting. This can offer conditions conducive to moisture entry/ termites/ decay/ mould growth and/or Structural damage to primary elements i.e. timber framing and/or damage to Secondary elements i.e. interior linings/ coverings. I recommend a licensed Roof restorer and/or Contractor further inspect for rectification – immediately.

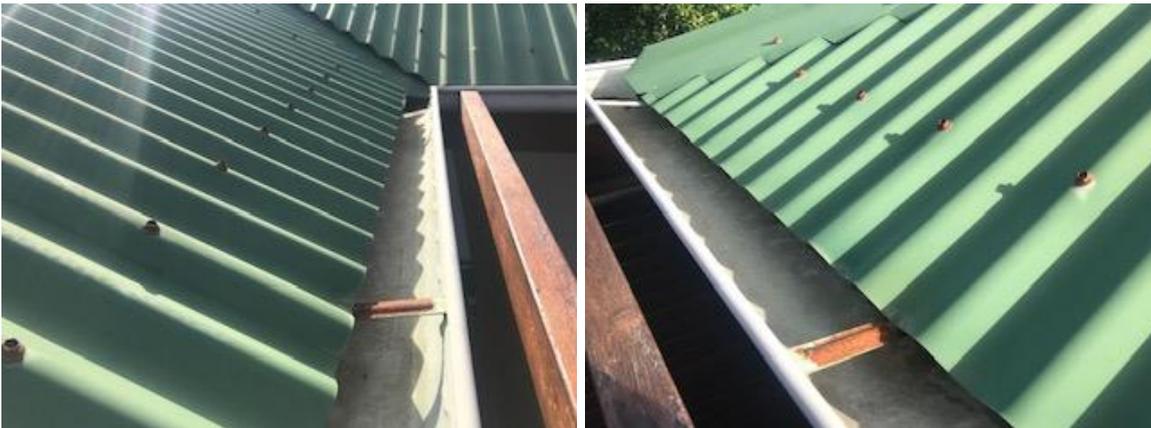
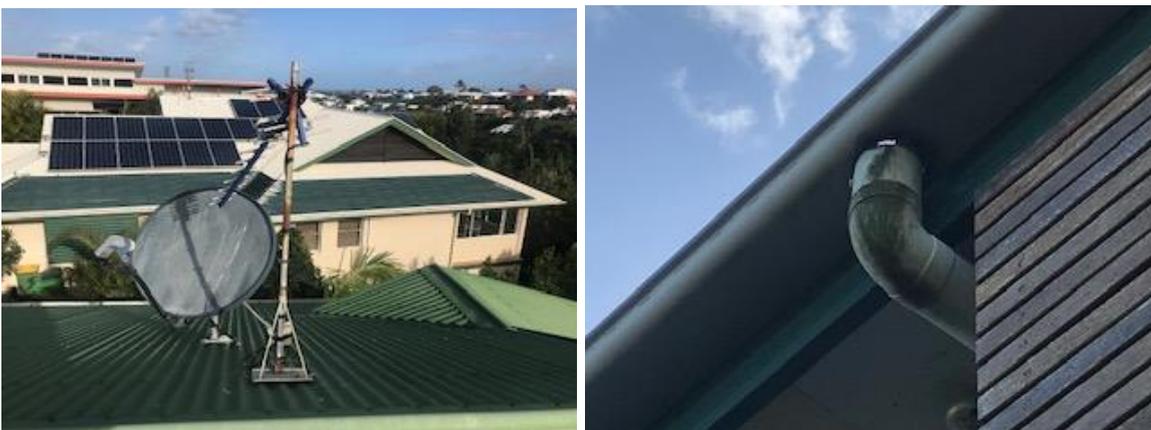
Roof screws that displayed: Some split/ bulging rubber seals/ washers that should be rectified and/or preferably replaced; Moderate stages of corrosion that should be spot treated/ coated and/or preferably replaced. This will offer conditions conducive to moisture entry/ termites/ decay/ mould growth and/or Structural damage to primary elements i.e. timber framing and/or damage to Secondary elements i.e. interior linings/ coverings. I recommend a licensed Roof Plumber and/or Contractor further inspect for rectification – immediately.

Early to advanced stages of corrosion that should be spot treated/ coated to: TV aerial, Gutter brackets & worse to NE gutter/ downpipe dropper. This will offer conditions conducive to moisture entry/ termites/ decay/ mould growth and/or Structural damage to primary elements i.e. timber framing/ footing movement and/or damage to Secondary elements i.e. interior linings/ coverings. I recommend a licensed Roof Plumber and/or Contractor further inspect for rectification – immediately.

Roof Flashing displayed/ consisted of: Silicone sealant only to: TV aerial/ Satellite dish cable roof penetration/s. Better methods of flashing could have been used i.e. flashing socks – rectification recommended. At an absolute minimum monitor these areas periodically i.e. 3 monthly maximum and replace sealant as required. Poor flashing offers conditions conducive to moisture entry/ termites/ decay/ mould growth and/or Structural damage to primary elements i.e. timber framing and/or damage to Secondary elements i.e. interior linings/ coverings. I recommend a licensed Roof Plumber and/or Contractor inspect for rectification – immediately.

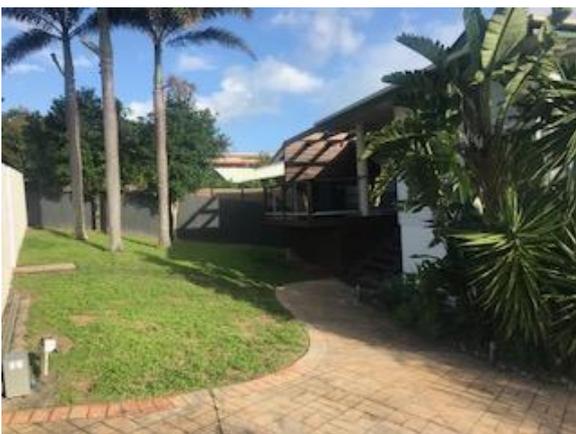
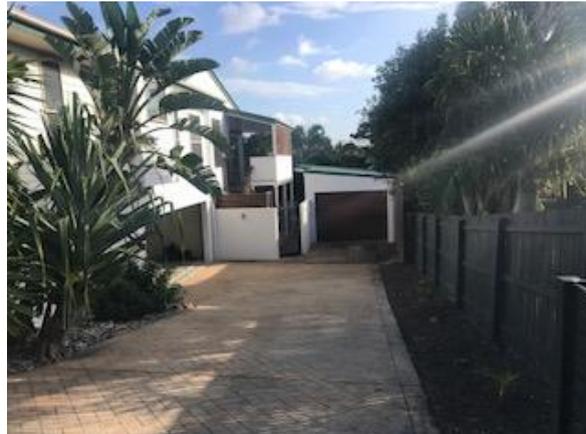
Surface drainage to the building was generally sound to poor i.e. worse to garden areas & uphill of the building. This offers conditions conducive to moisture entry/ termites/ decay/ mould growth and/or Structural damage to primary elements i.e. timber framing/ footing movement and/or damage to Secondary elements i.e. interior linings/ coverings. The current NCC requirement is for surrounds to slope away from external walls at a slope of 50mm for a distance of 1.0m minimum and/or spoon drains be instated up hill to divert water around the building/s. I recommend a licensed Contractor further inspect for rectification – immediately.

Gardens were up towards external elevations of the building i.e. north, west and should be moved well away as they offer conditions conducive to moisture entry/ termites/ decay/ mould growth and/or Structural damage to primary elements i.e. timber framing/ footing movement and/or damage to Secondary elements i.e. interior linings/ coverings. I recommend a licensed Contractor further inspect for rectification – immediately.

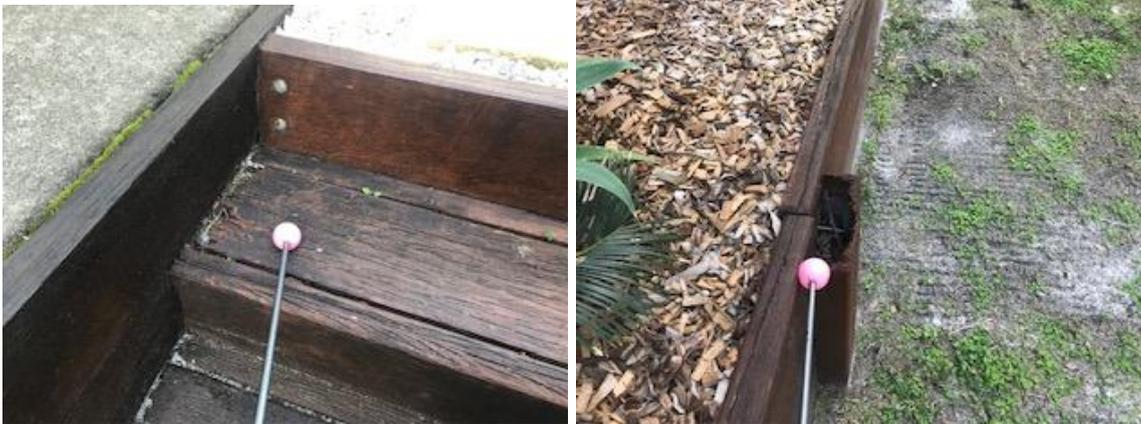
Timbers in contact with ground to: Sleepers/ edges / Fences etc to property are not recommended as they offer conditions conducive to mould growth, decay, termites and/or Structural damage and should preferably be rectified/ removed. I recommend a licensed Contractor further inspect for rectification – immediately.

Poor paint/ oil cover to: Sleepers/ edges / Fences etc that offers conditions conducive to moisture entry/ termites/ decay/ mould growth and/or Structural damage. I recommend a licensed Contractor further inspect for rectification – immediately.

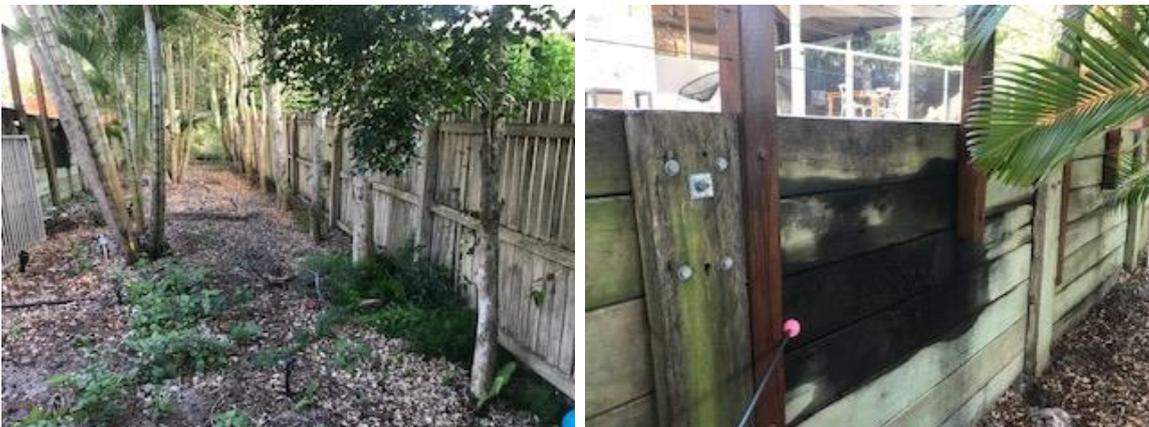
Early to moderate / advanced stages of weathering/ splitting and/or decay/ moisture damage to: Sleepers/ edges / Fences etc. This is also a structural type defect. An invasive inspection is recommended to further investigate the cause and the extent of any damage. Any moisture/ decay/ timber pest affected timbers/ members then be treated with an anti-fungicide treatment and/or sealed/ oiled/ weather proofed and/or rectified as required. I recommend a licensed Contractor further inspect for rectification and/or a licensed Structural engineer certify as sound – immediately.

AS3660 “Termite management” recommends a minimum clearance of 50mm from fence timbers to finished surface level to decrease possibility of decay and termite damage.

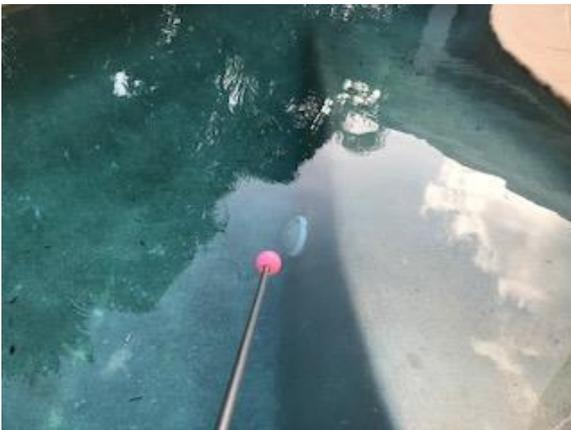
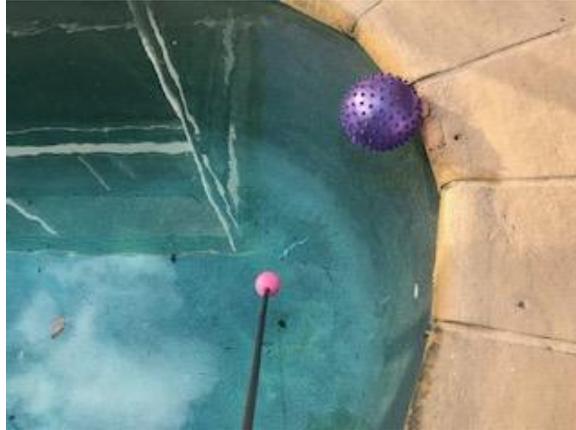
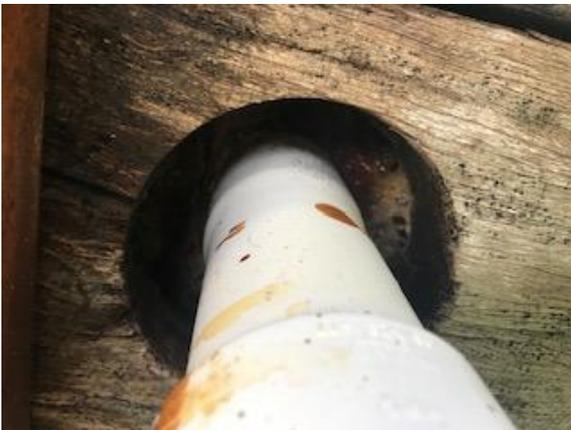
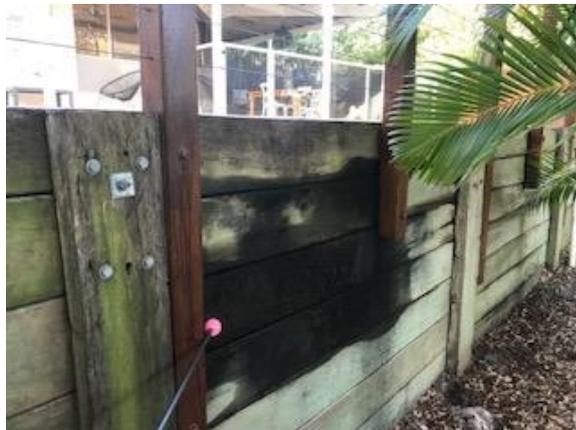
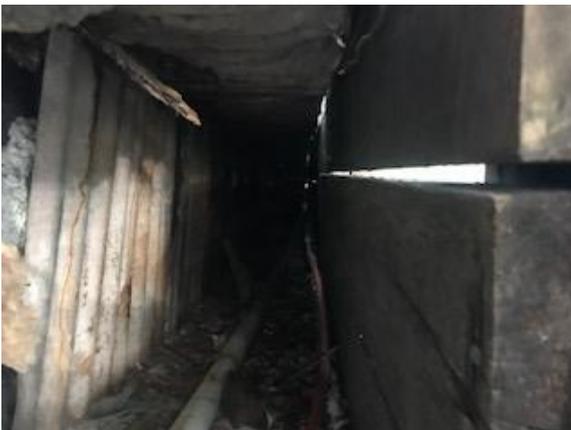
Swimming pool – “Outside The Scope Of This Inspection” however displayed: Cracking/ seepage/ blemishes; Damaged light. I recommend a licensed Pool consultant further inspect for rectification and/or a licensed Structural Engineer certify as sound – immediately.

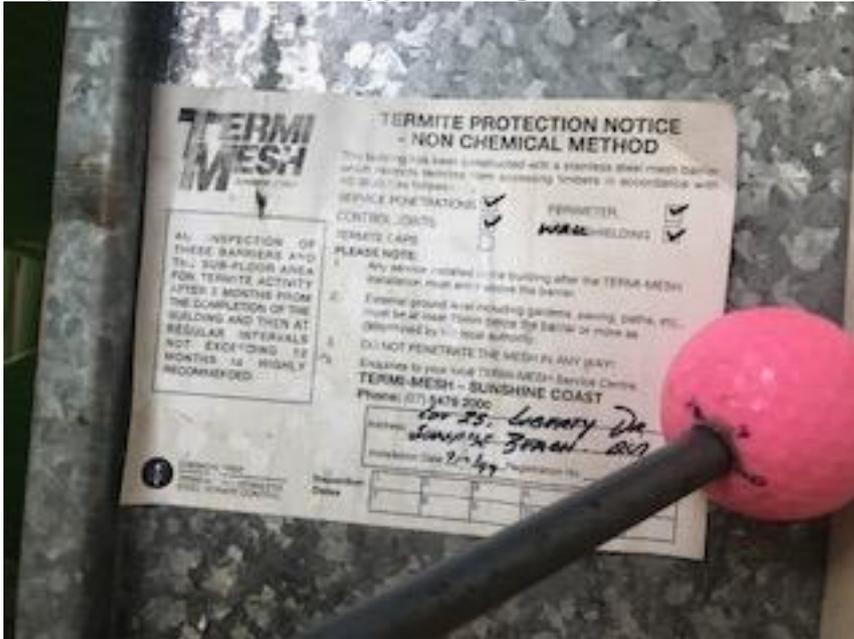
**Termite management notice located in meter box for:
Physical “TermiMesh” type management system dated 9/7/97.**

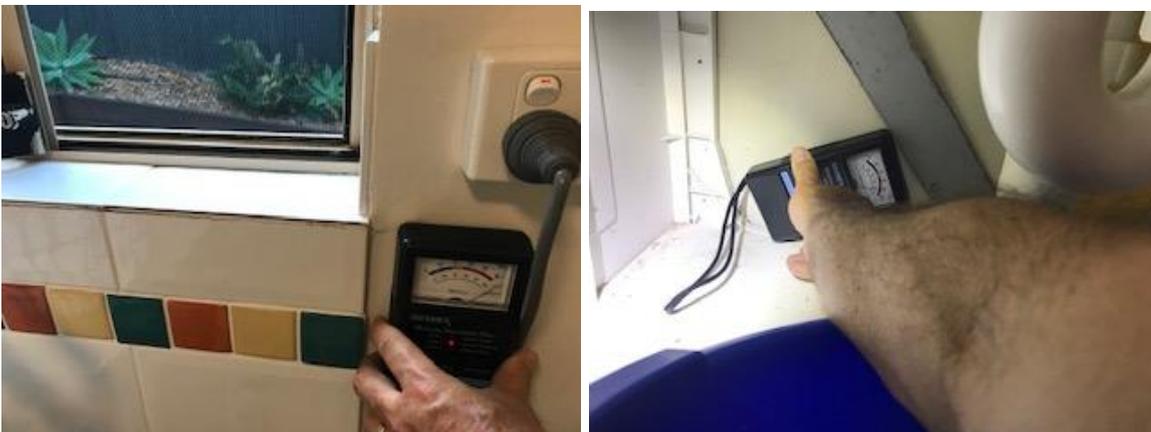
High moisture readings were evident to but not limited to: Lower storey walls i.e. subfloor & external walls as shown; Swimming pool area. I recommend a licensed Water proofing consultant and/or Contractor further inspect for rectification – immediately.

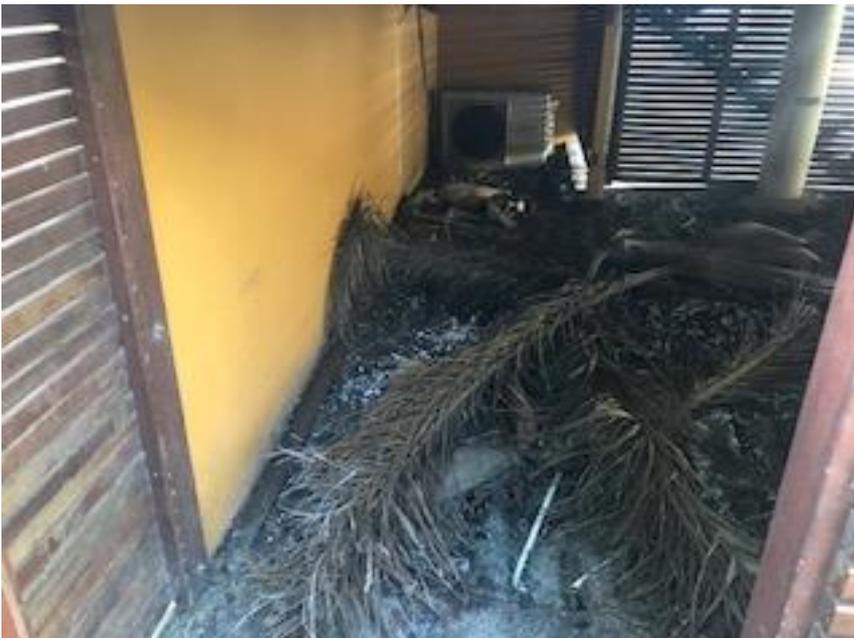
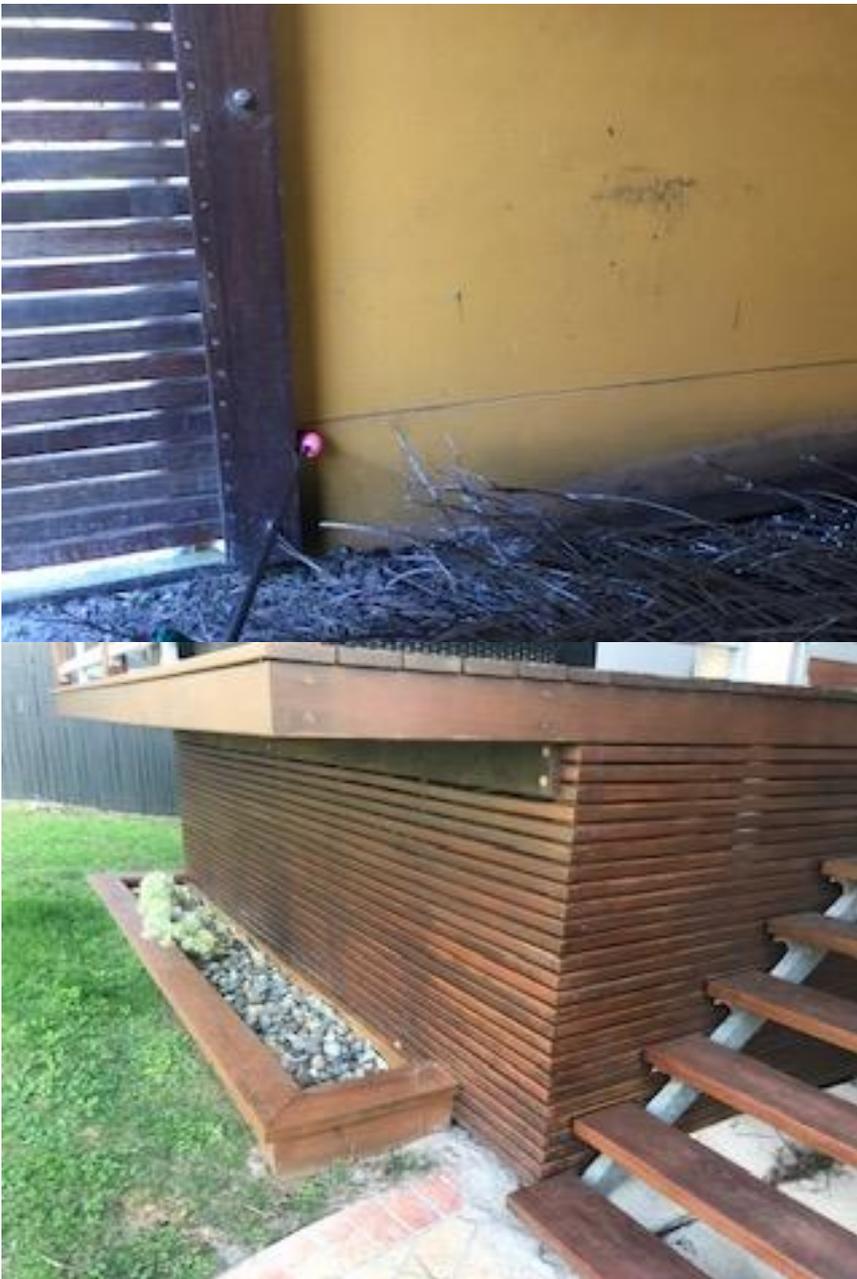
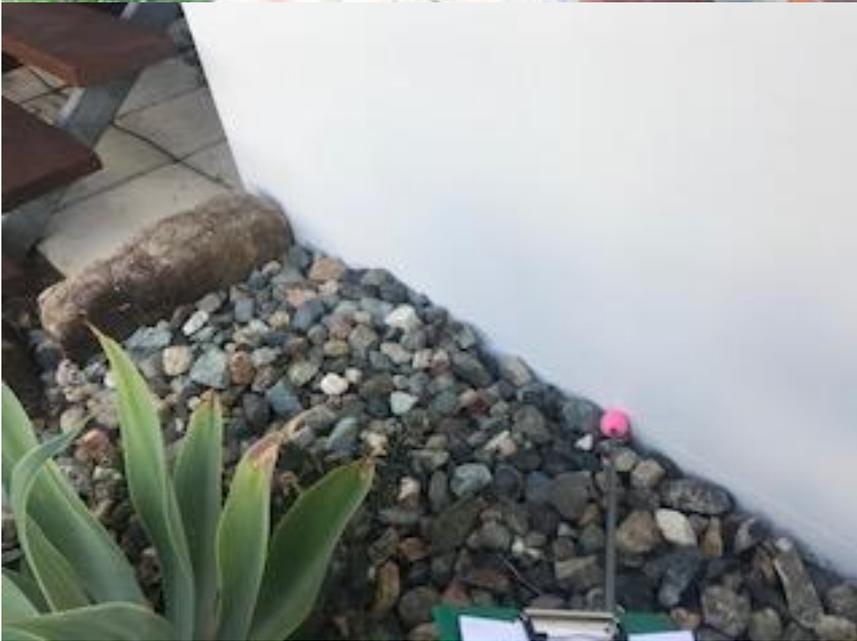
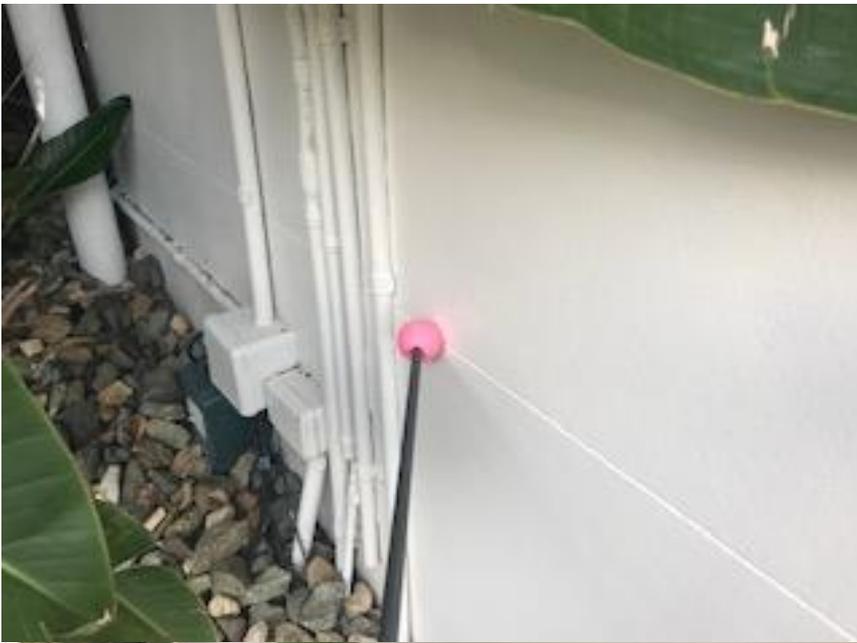
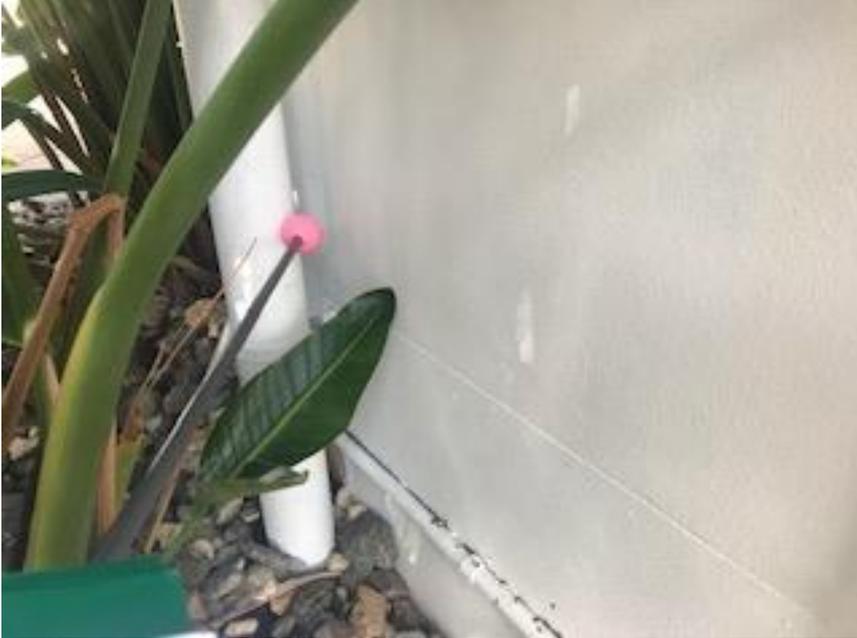
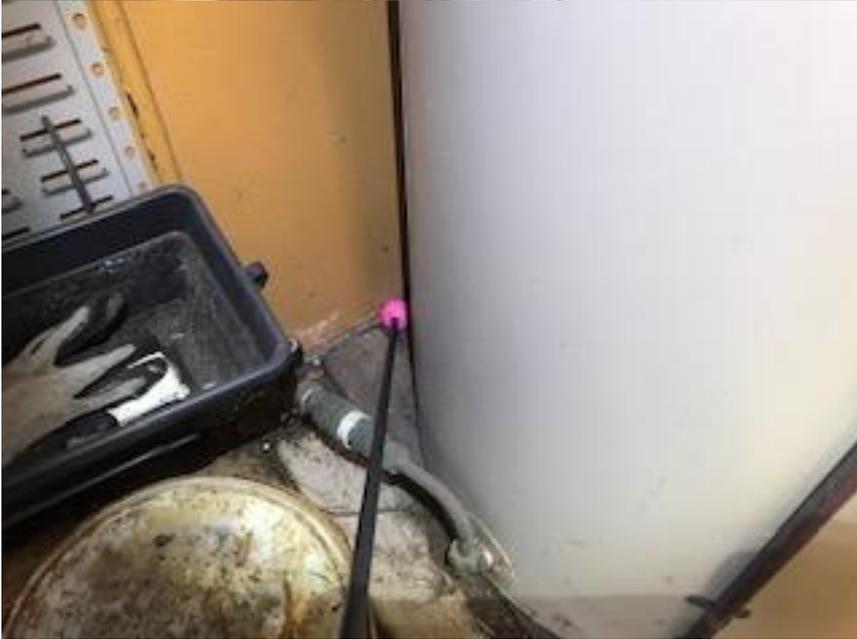
Areas obstructing/ covering the visual inspection zone to: Vegetation i.e. north/ west.

Any Fences/ hot water systems, gas bottles etc should be separated a minimum of 25mm from the dwelling to comply with AS3660 "Termite Management". Clarify termite management (Certificate of Installation required) for property and if not current instate a perimeter treatment immediately i.e. rectifying bridging/ breaching and visual clearances (i.e. instate 75mm visual clearances) to management system and/or installing a chemical type management system.
